Composite Failure Analysis Handbook Update #1

Boeing Defense & Space Group

April 1995

Final Report for the Period Aug 90 - Apr 95

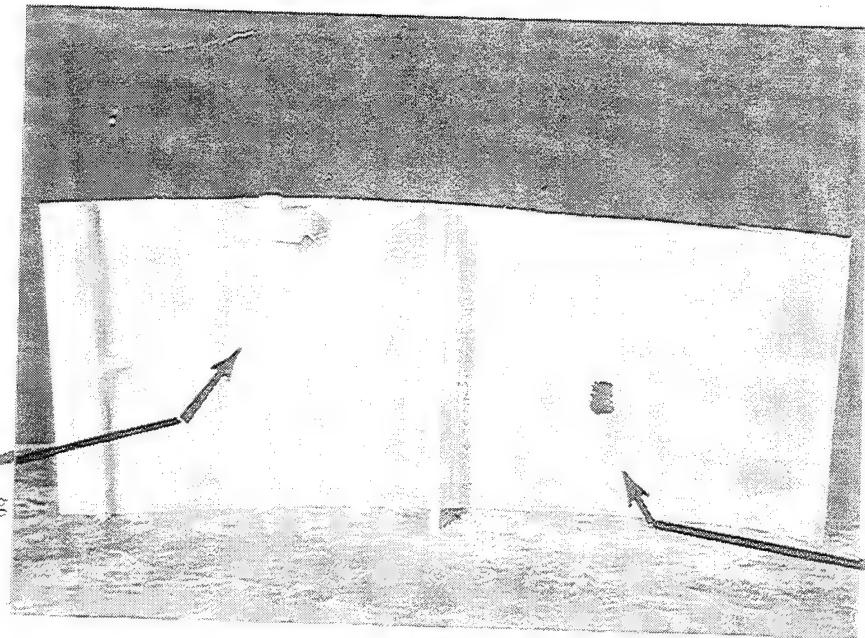
Figure 3. Photograph of the Inner Surface of the Upper Wing Surface

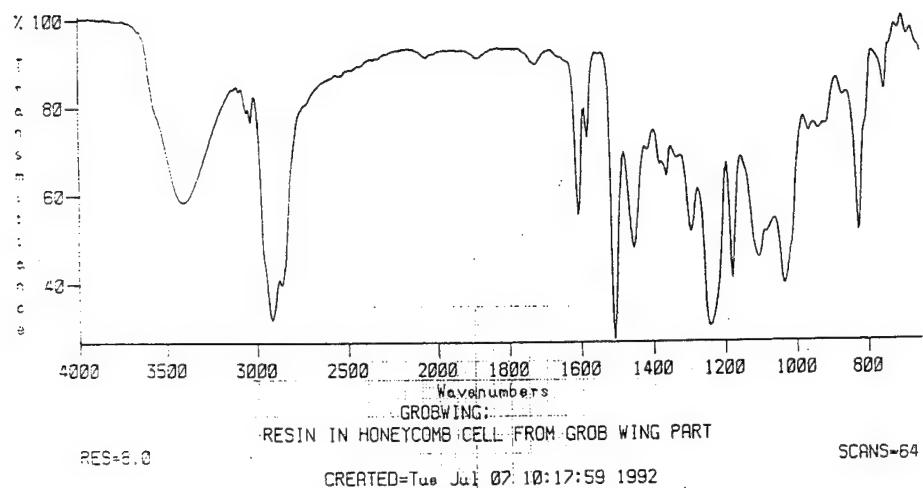
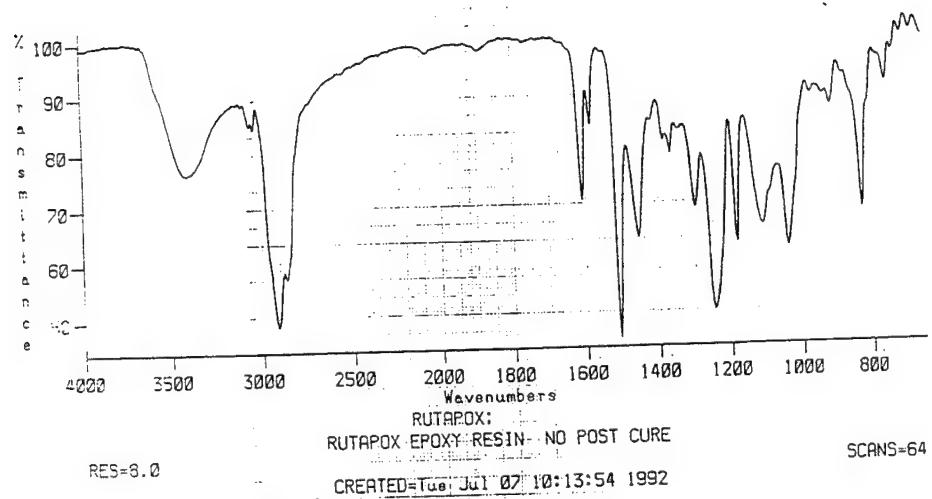
A Fourier Transformation Infrared (FTIR) analysis, used for determining the formulation of polymers, was performed on a sample of the resin used in the skins and compared to a sample of a partially cured Rutapox resin. The analysis indicated that both samples were essentially identical, confirming that wing section was fabricated using the Rutapox resin system (Figure 5).

Figure 5. FTIR Plots of the Wing Section Specimen and the Rutapox
 a) Wing Section Sample
 b) Non-Post-Cured Rutapox Resin Sample

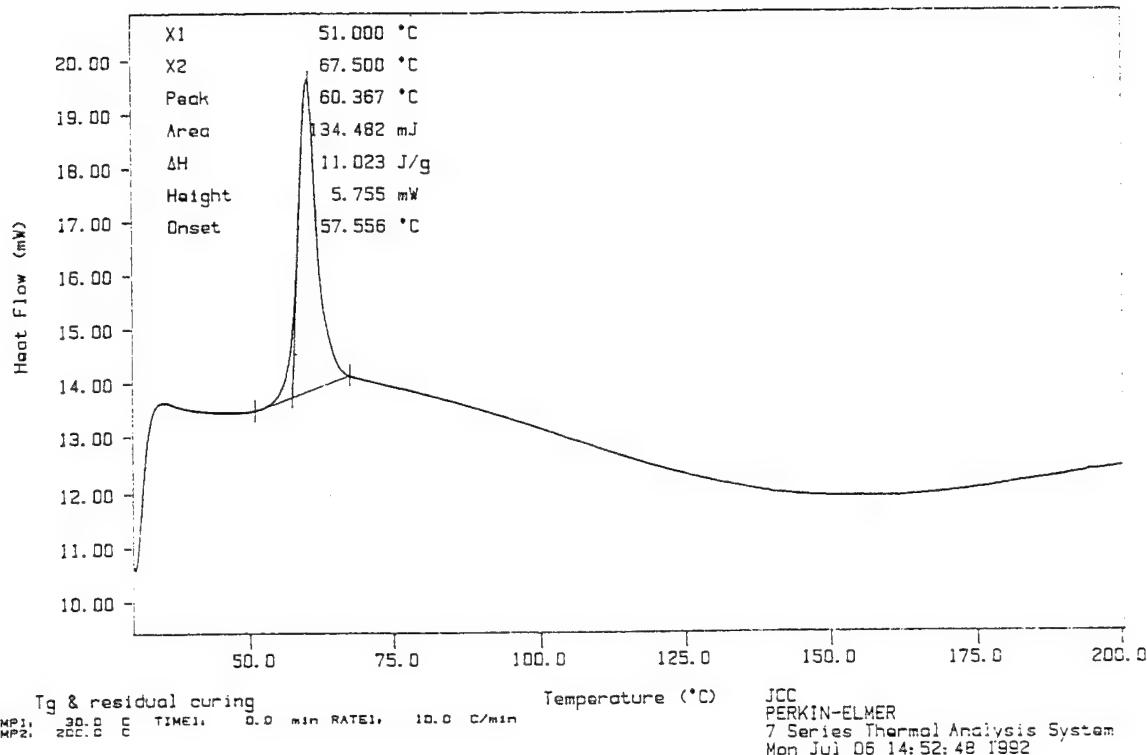
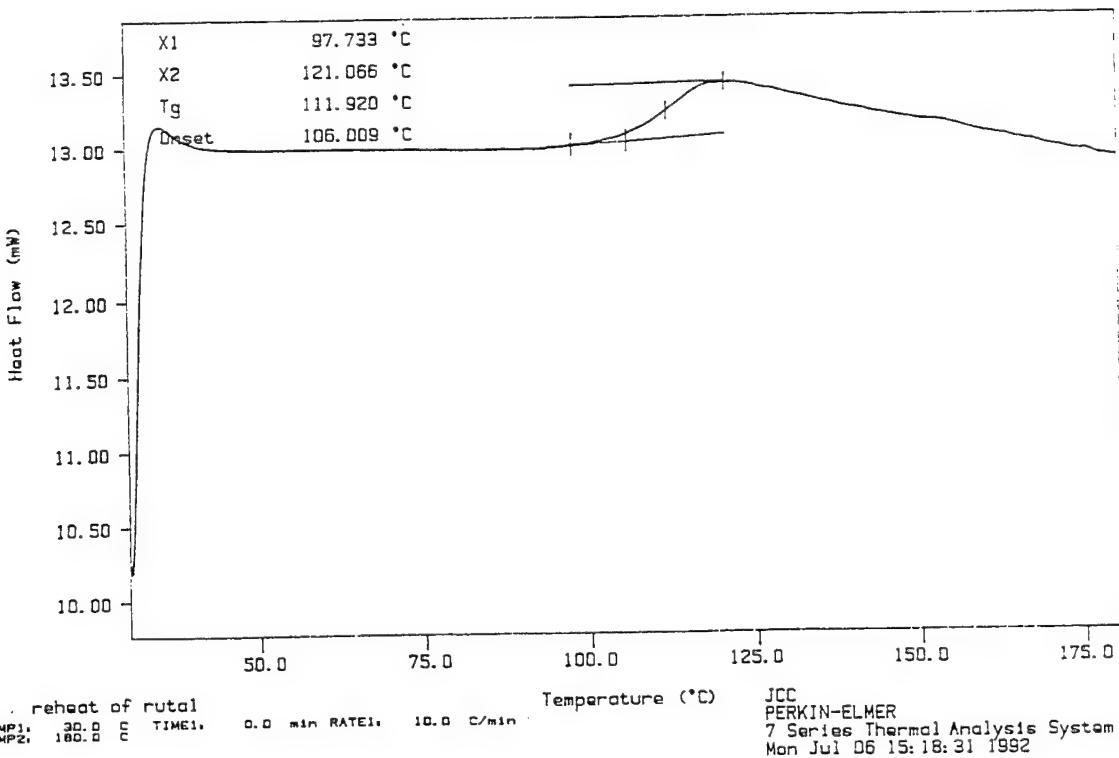
Figure 6. DSC Plots of the Non-Post-Cured Rutapox Sample

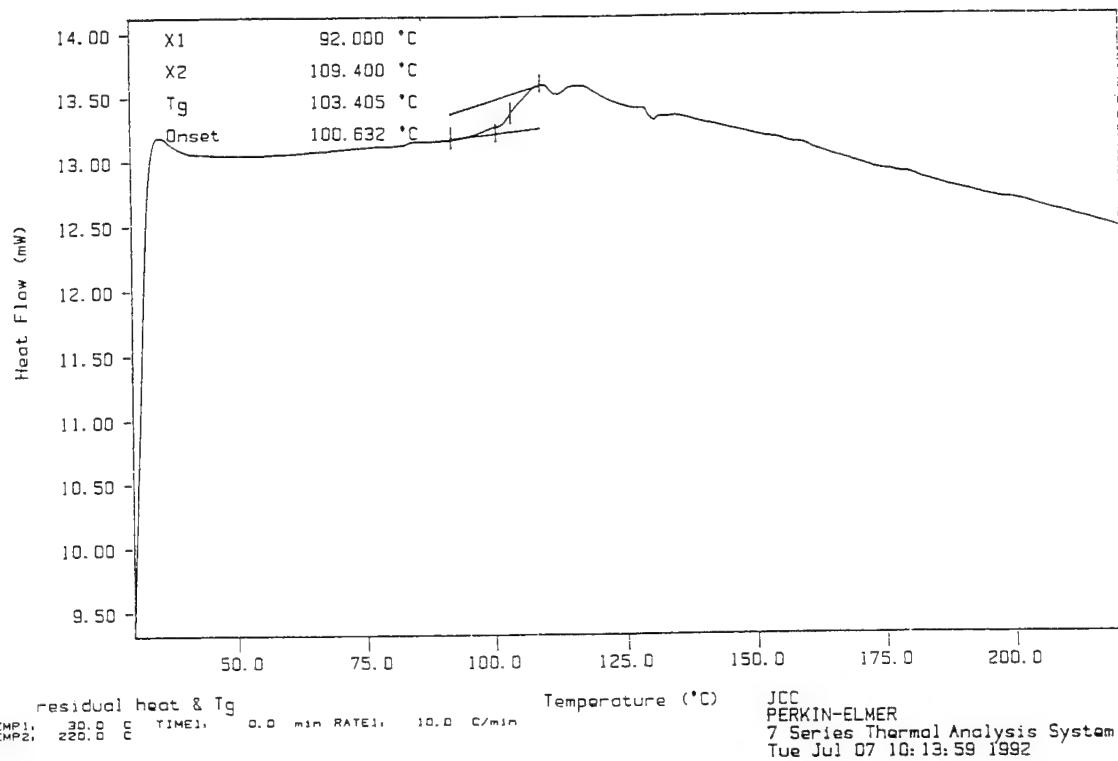
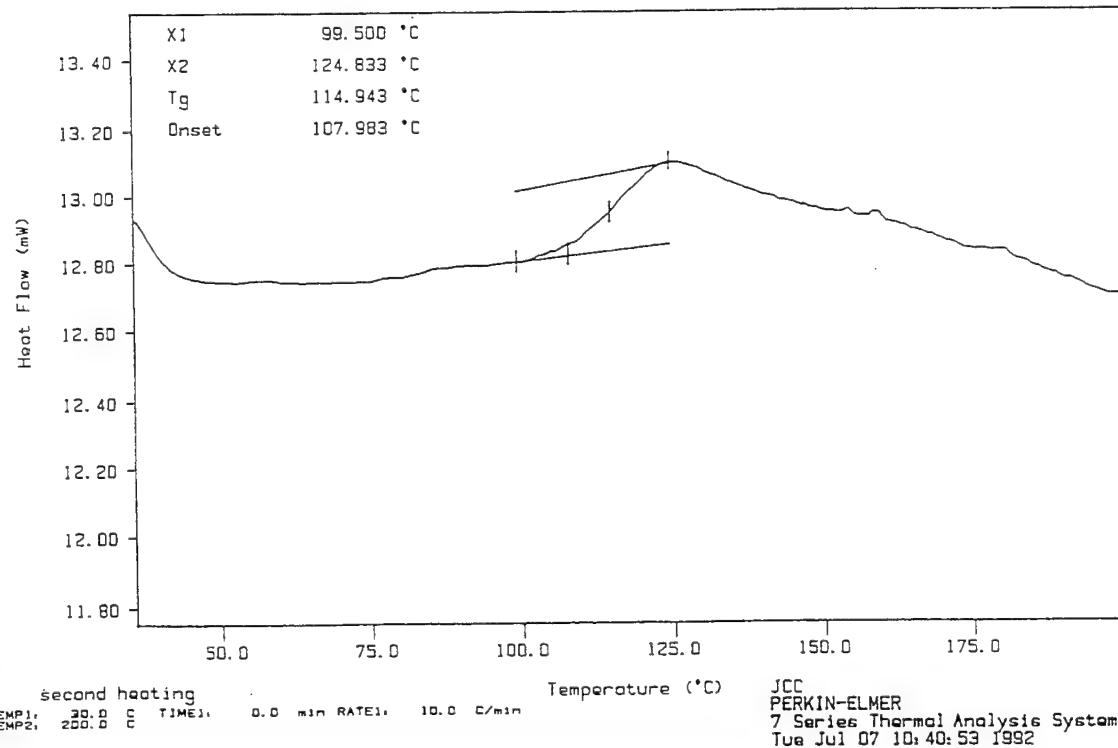
observed on either analyses and the Tg was 103° C and 115° C for the first and second tests respectively. This indicates that the resin in the wing section had been fully cured (Figure 6 & 7).

Figure 7. DSC Plots of the Wing Section Specimen

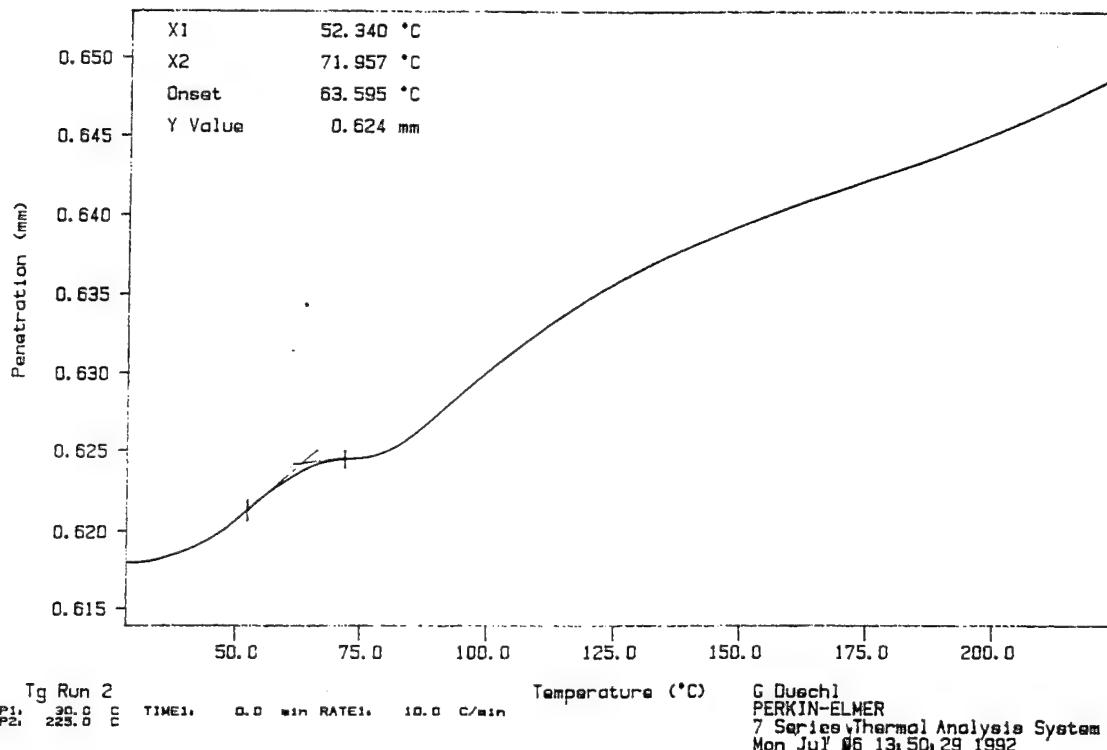
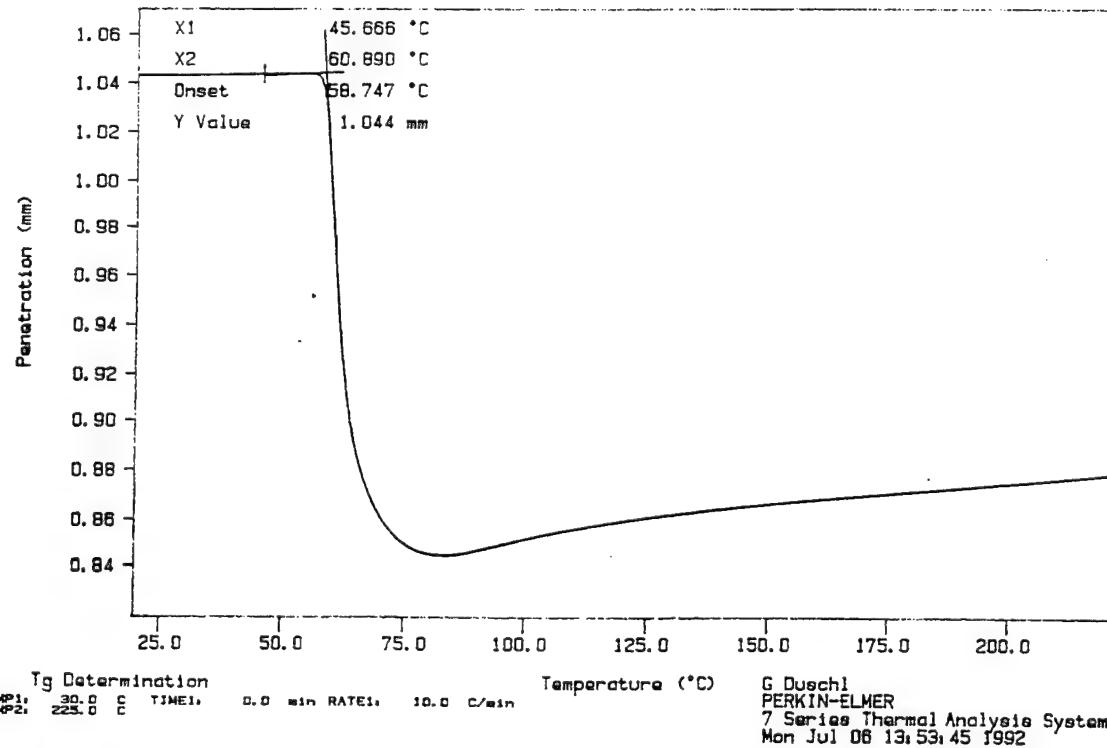
Figure 8. TMA Plots of the Non-Post-Cured Rutapox Sample

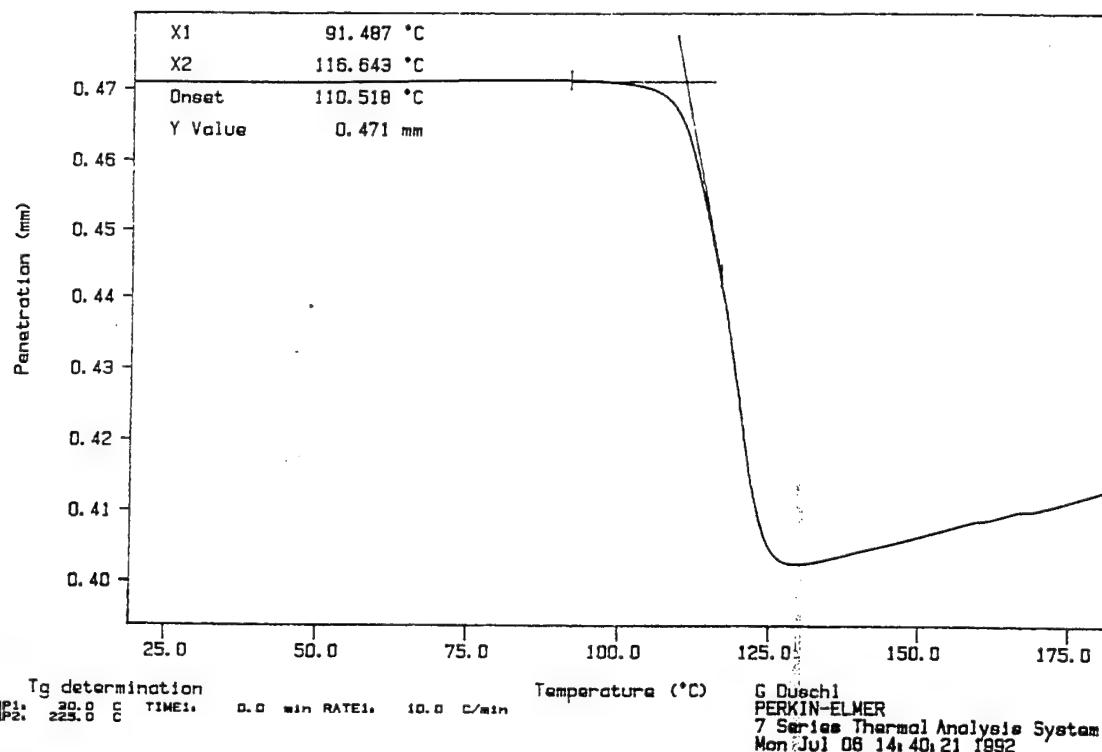
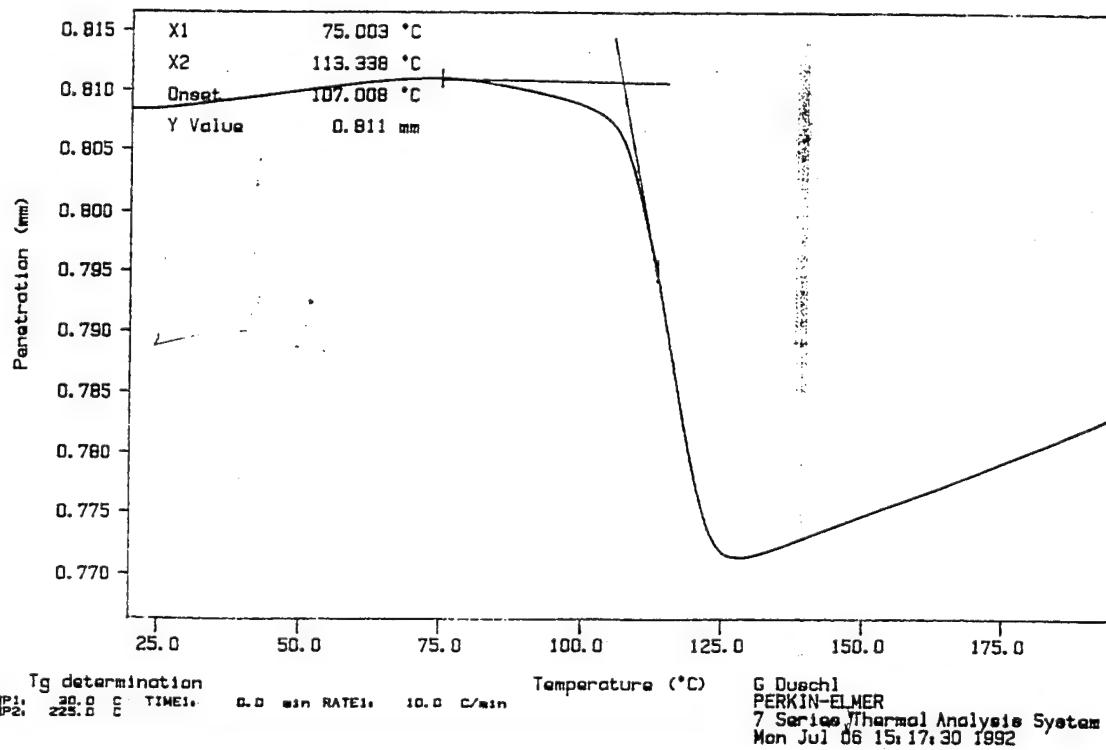
Thermo-mechanical Analysis (TMA) is another method to determine the Tg of a polymer. Again two specimens were tested; a non-post cured sample and a sample from the wing section. The first heat cycle of the non post-cured specimen revealed a definite Tg indication at 59°C. Testing of the resin from the wing revealed a Tg of 110°C and 107°C from the first and second runs, respectively. The difference between these two tests confirmed that the wing sample was fully cured because the Tg values were similar to the DSC analysis and that the uncured specimen exhibited a lower Tg and an exotherm. (Figure 8 & 9).

Figure 9. TMA Plots of the Wing Section Specimen

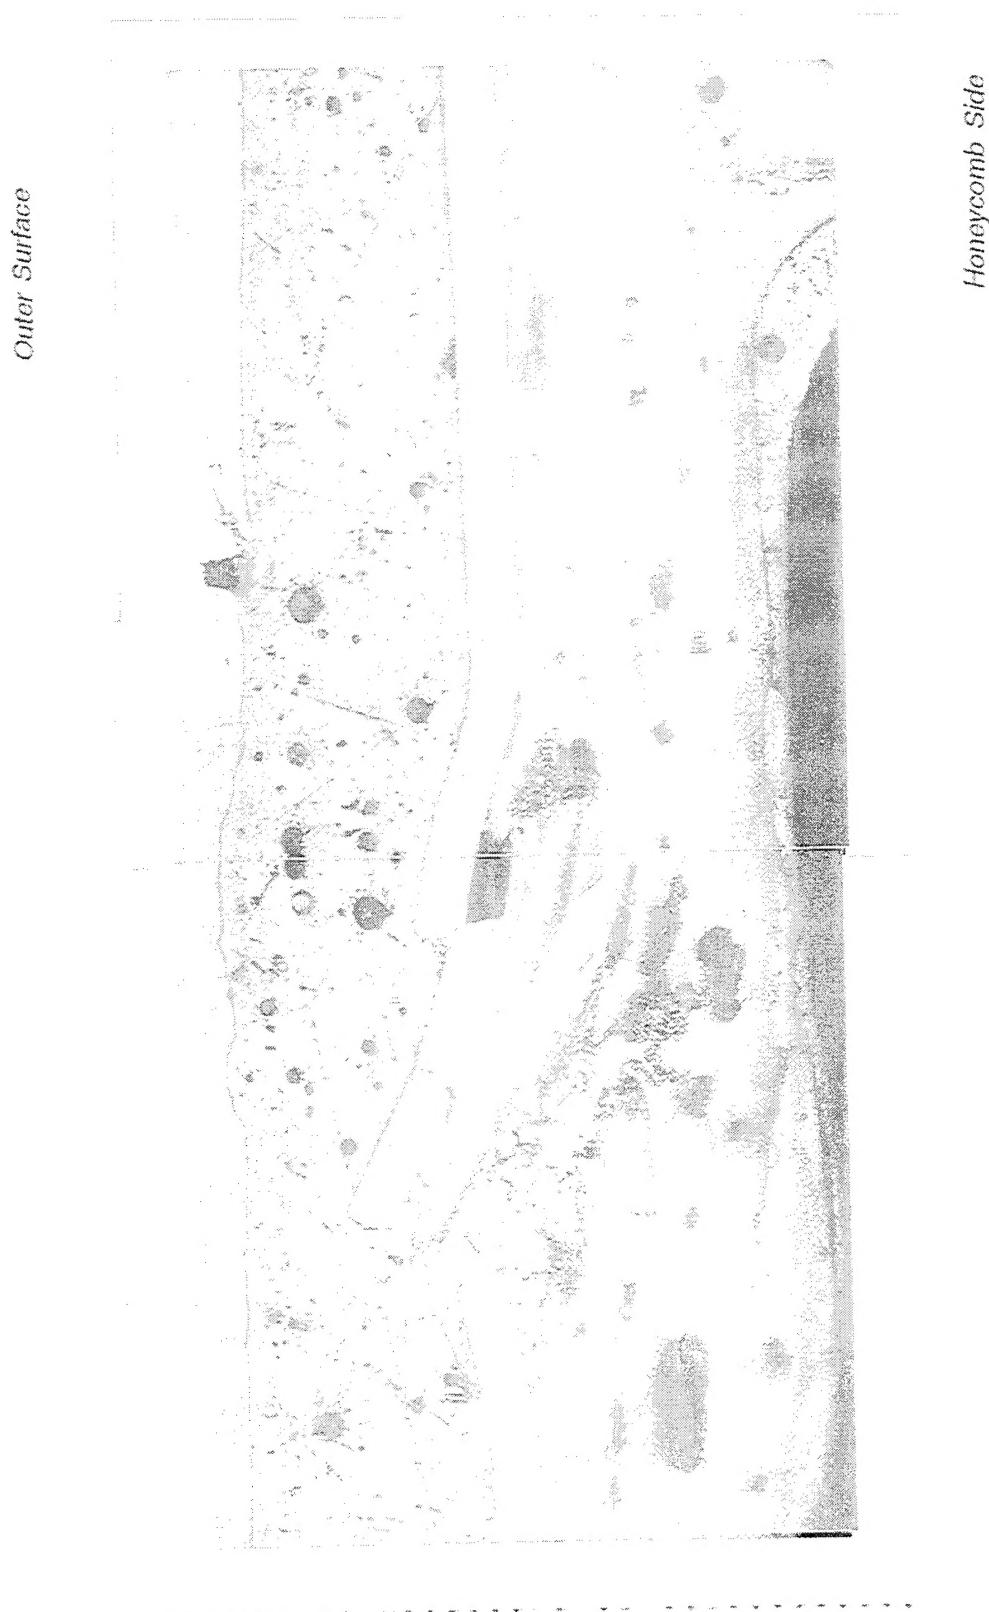
Figure 11. Cross Section through a Crack in the Upper Wing Skin

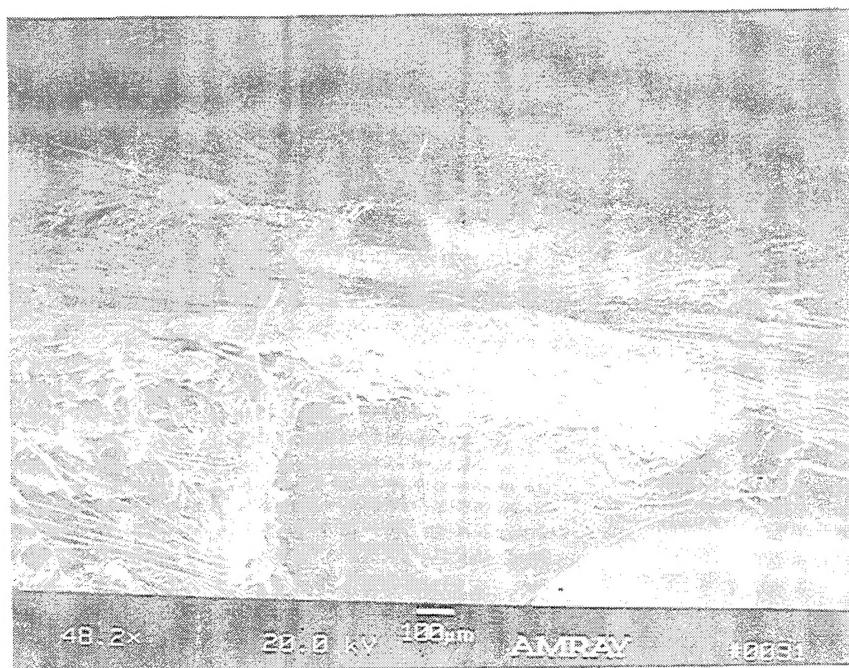
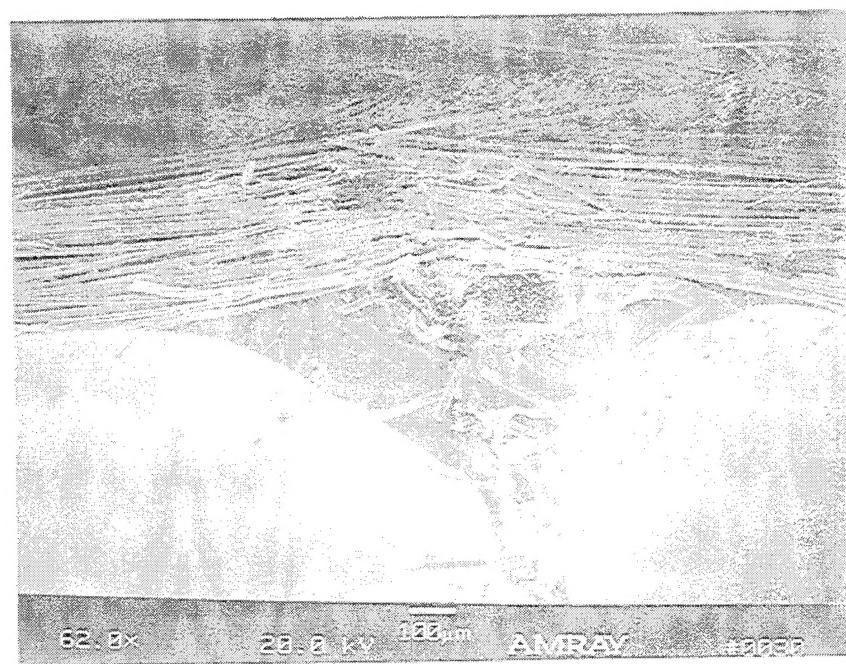
The two specimens that were able to be separated were coated with Au-Pd and examined using a SEM. The fracture surfaces were frayed with numerous loose fibers pulled from the crack surfaces (Figure 12). The fabric tows perpendicular to the crack direction were bent upward. Closer examination of these fiber ends revealed fractures consistent with compression failure, initiating at the bottom of the fibers. The dominate fracture

Figure 12. SEM Photographs of the Crack Surfaces

feature on the both the fibers parallel and perpendicular to the crack were the hackles indicating a mode II (shear) loading.

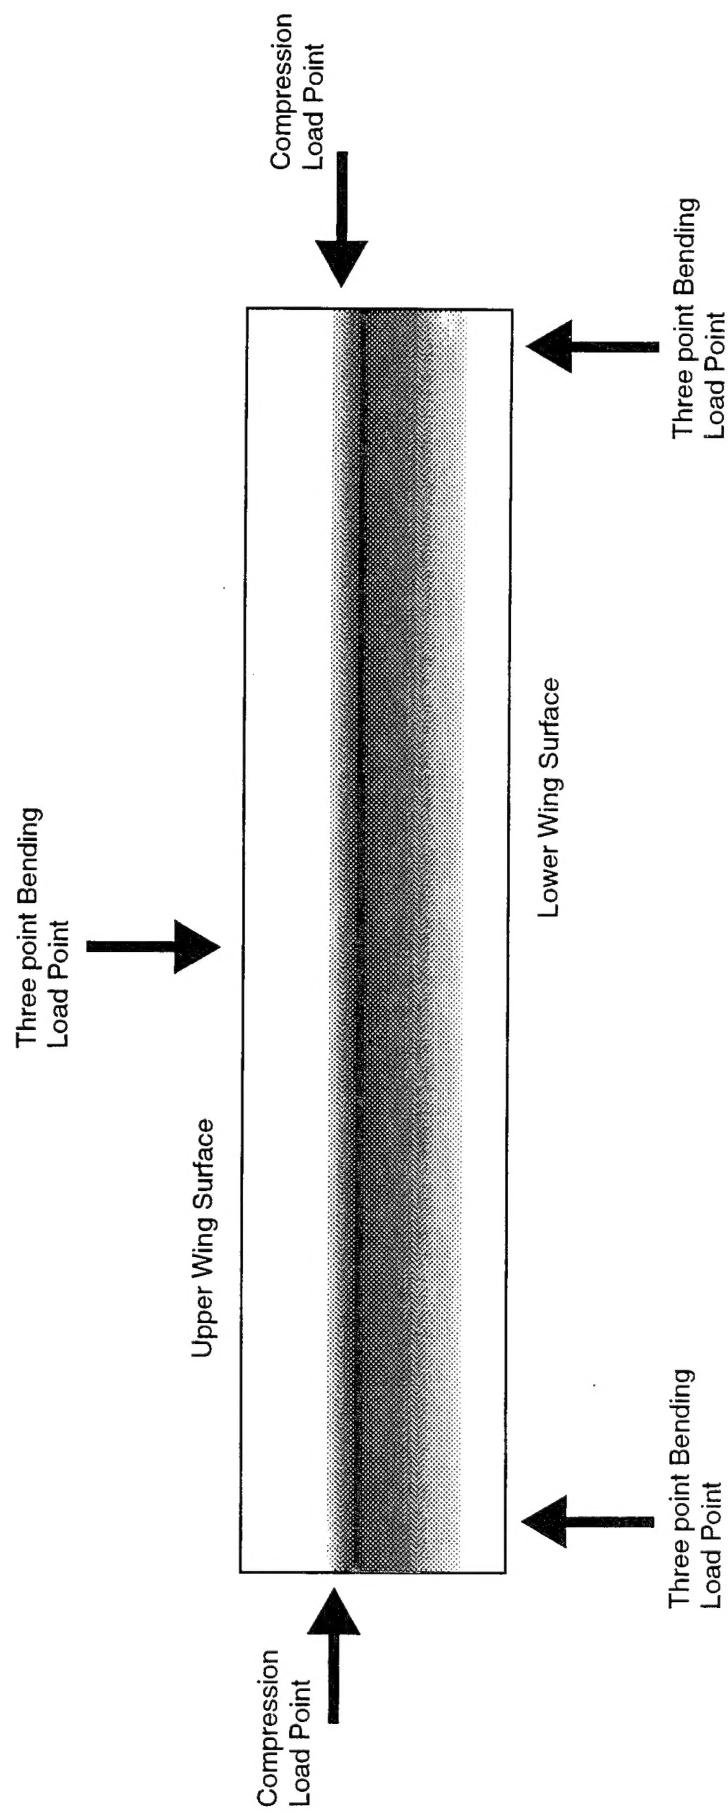
1. The wing section contained two major cracks which extended from the leading edge of the wing to the aft edge. Another small crack was located at the edge, in the middle of the wing section. All of the cracks were on the upper wing skin.
2. Chemical analysis of the materials did not reveal any anomalies in the materials. No material or fabrication anomalies which could have contributed to crack initiation were found.
3. Cross-sectional and SEM analysis revealed the fractures were caused by buckling of the upper skin. The specific cause of the buckling could not be determined.

Figure 13. Diagram of the two Proposed Loading Configurations Which could Cause the Upper surface to Buckle
